# Case Study: IR Light to Examine the Writing Trail

by August Meyer, QDE

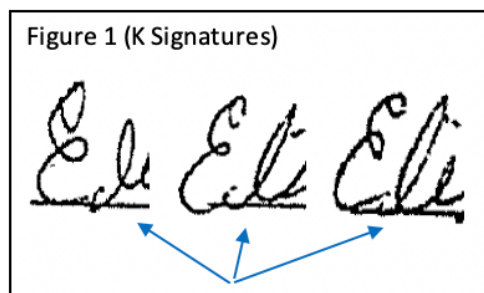
In figure 1 we see three cutouts showing the 'El' connector from known signatures. These signatures were included in the initial paperwork provided to me for review. We immediately notice these are multi-generational photocopies or scans and are degraded significantly as a result. While there is still enough detail left to conduct an examination, any conclusions must be reached with a level of skepticism, and opinions should be qualified as having been made based upon non-original documentation.

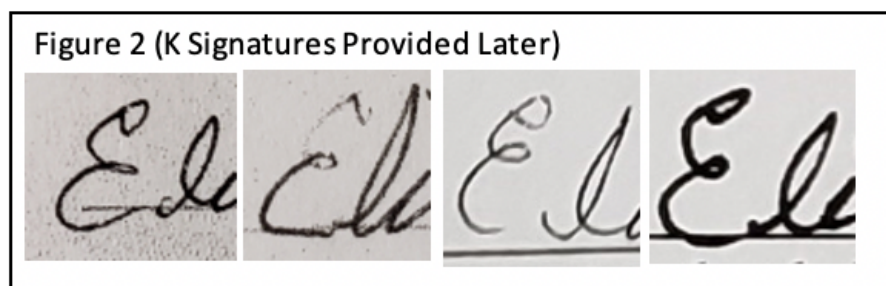
Figure 2 has an additional four known signatures with better quality. These known signatures were later provided to me for my examination but were also non-original. The writer has a tendency to make a slight hook or apex with the connection rather than a smooth transition from one letter to the next. In some known signatures, there was a clear pen lift.

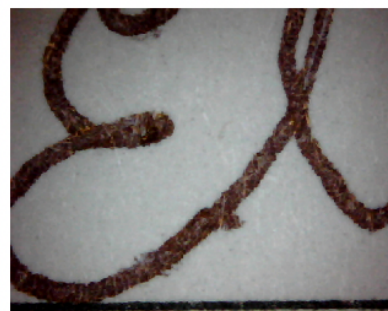
Figure 4 shows the original document under microscope with visible LED lighting. Having the original document to examine we can clearly see the extra ink bump which was initially interpreted to be indicative a pen lift. With this lighting and magnification, it appears to be one continuous writing trail and the bump the result of ink gooping.

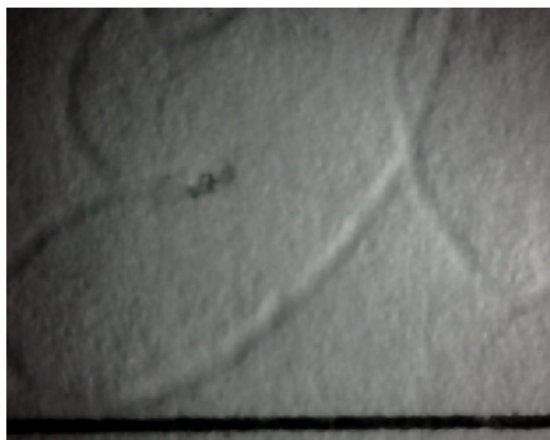
Figure 5 shows the original document placed under infrared (IR) lighting. With the pen ink transparent we can see the pen impression in the paper clearly showing one smooth line. Using IR oblique lighting, there are no doubts the connection between the 'El' is one continuous stroke. This was inconsistent with the known signatures and disproved the theory of a pen lift.
